A LONG-LIFE CONTINUOUSLY REINFORCED CONCRETE PAVEMENT IN SERVICE SINCE 1976 IN SPAIN. WIDENING AND FUTURE.

ABSTRACT

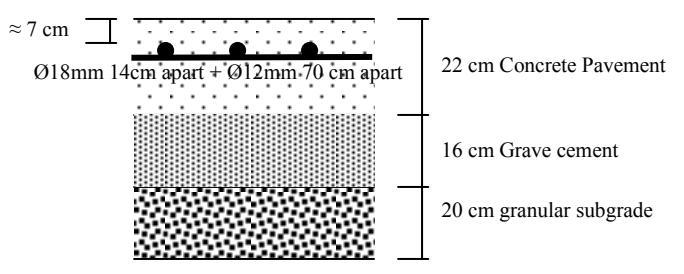
Figure 1 – Pavement section

Pavement layers are, from bottom to top, 20 cm of selected granular soil with a CBR index more than 50, 16 cm of grave cement and a continuously reinforced concrete pavement, 22 cm thick (figure 1). A 4% cement and crushed siliceous aggregate were used in the cement treated base. The compressive strength was 9.3 MPa after 28 days obtained on cylindrical specimen Ø 15 x 18 cm. This was placed by compaction obtaining 100% of the modified Proctor maximum density.

A minimum flexural strength of 4.5 MPa after 28 days was required in the concrete of the pavement. Longitudinal reinforcement consisted of \emptyset 18 mm steel bars, 14 cm apart, in the main pavement built in 1976 and \emptyset 16 mm steel bar, 11 cm apart, in the additional climbing lane built in 1990 (\emptyset 18 mm bars were no produced then). Transverse reinforcement was placed with \emptyset 12 mm steel bars separated 70 cm and located with an angle of 60° with the longitudinal ones. Stands separators (\emptyset 12 mm) hold the bars 7 cm under the surface level of pavement.

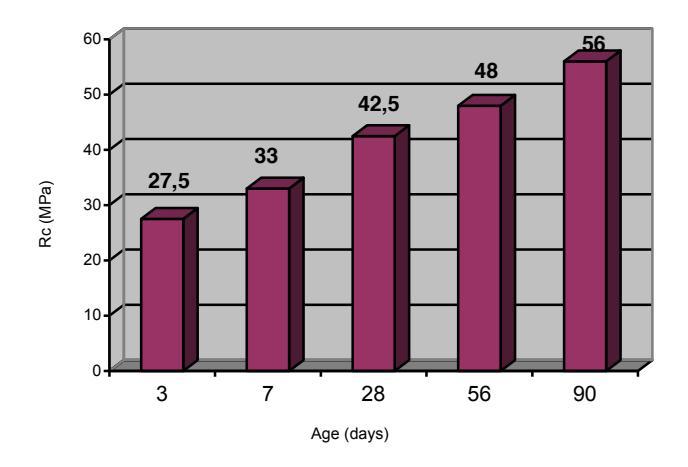
Figure 2 – Concrete compressive strength (MPa)

A flexural strength of 5.1 MPa and 6.8 MPa were obtained after 7 and 28 days respectively. Prismatic specimens $15 \times 15 \times 60$ cm were used. Compressive strength was obtained on cylindrical specimen Ø 15 cm x 30 cm as contrast control. Strength values are shown in Figure 2.

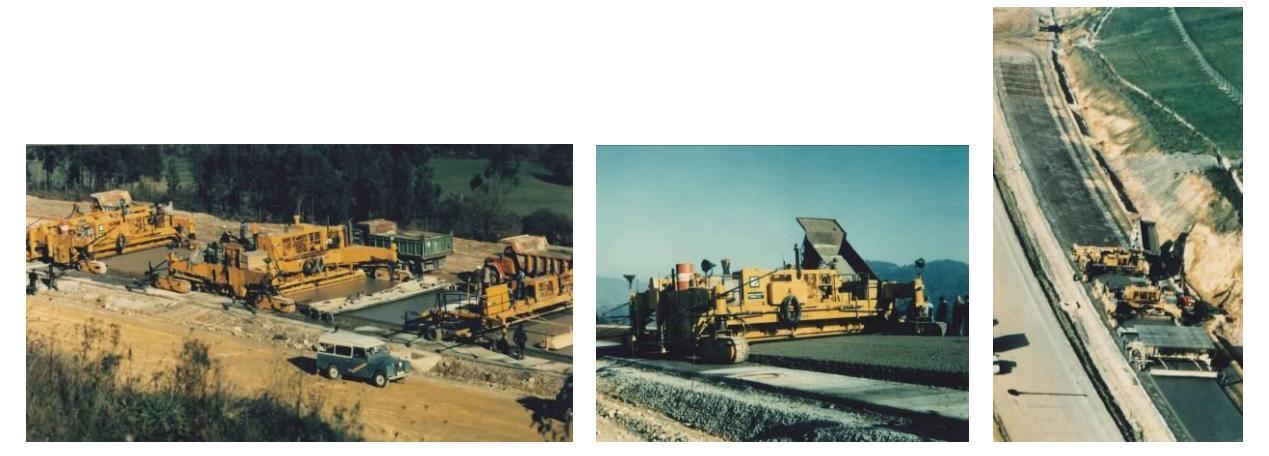
Photos 5, 6 and 7 - Pavement was built with slip form paver during 1974-75

The pavement was built with a CMI slip form paver. Previously, another machine spread the concrete that was transported with trucks that drove along the shoulder. A third team sprayed the curing liquid and made the transverse texture with a mechanic steel brush.

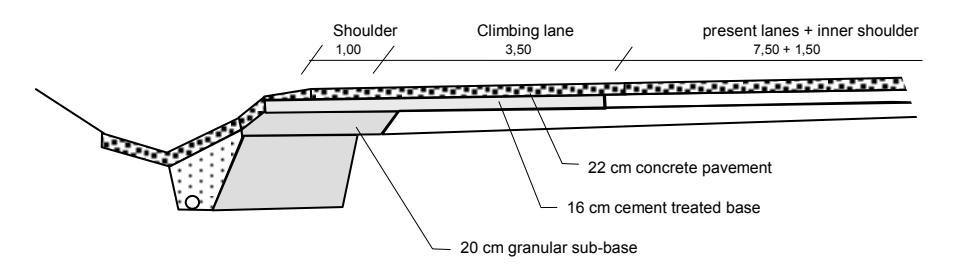
Figure 3 – Cross section of the additional climbing lane

The concrete placed in the in the additional climbing lane built in 1990 (figure 3), was made in a ready-mix plant. Cement amounts of 380 kg/m³ of special road cement, produced with approximately 50% of fly ash, and the same siliceous aggregates were used. Water-cement ratio applied was 0.44 and 0.3% plasticizer agent was added in order to get a slump measured with the Abrahms cone of 8 cm in the plant and 4 cm on site. Asphalt top layer was laid on the bridge slabs as in the first pavement.

The same pavement was designed in the additional climbing lane built 14 years later, even if Spanish specifications required a higher thickness section and a smaller reinforcement ratio. As Ø 18 mm steel bars were not produced, Ø 16 mm bars separated 11 cm (instead every 14 cm) were placed as longitudinal reinforcement. The transverse reinforcement was also replaced by Ø 10 mm steel bars (instead Ø12 mm) separated 80 cm forming an angle of 60 degrees with longitudinal ones.

Tie bars Ø12 mm (80 cm long) was placed every 1 m between lanes to anchor the additional lane to the old one. Previously, holes were drilled in the middle of the concrete layer thickness and mortar without shrinkage was introduced in them to glue the bars.

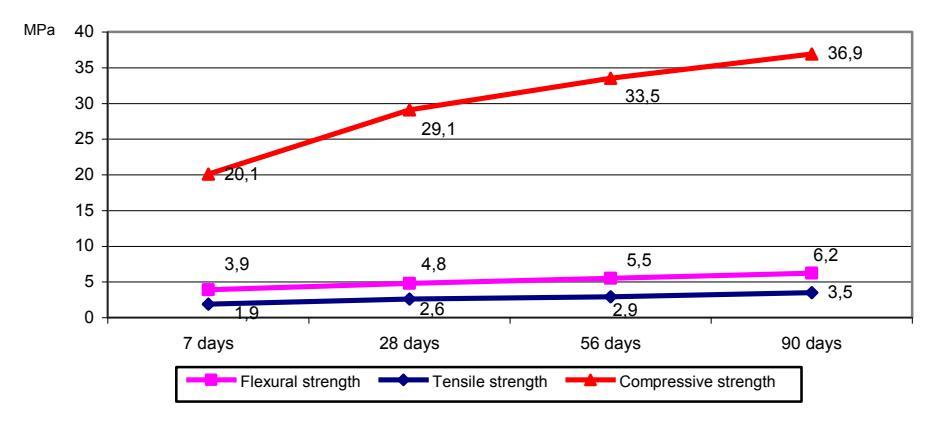
Figure 4 – Strength values of concrete used in the widened lane

Strength values of this concrete are included in Figure 4. Prismatic specimen $15 \times 15 \times 60$ cm and cylindrical specimen Ø 15×30 cm are used in flexural and compressive strength respectively.

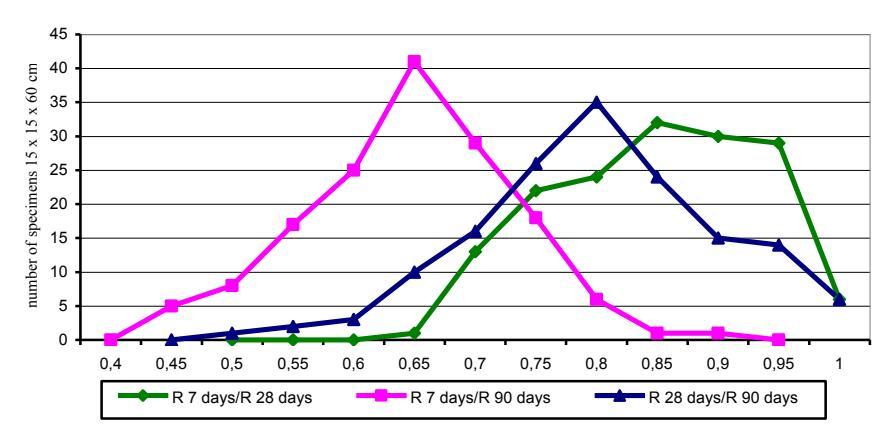
Figure 5 – Ratios of flexural strength at different ages

Ratios of flexural strength at different ages are shown in figure 5.

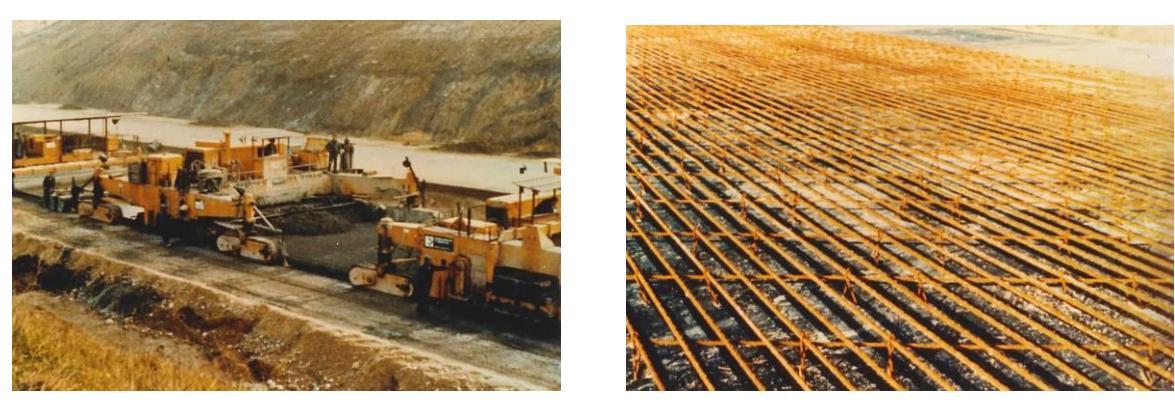
Amount of 0.847% was used to design the steel section considering the concrete - steel adherence and the base – slab friction. A test section, which was lowered to 0.73%, was made (values higher than those required in present Spanish specifications).

Photos 8 and 9 - Pavement construction and reinforced bars detail

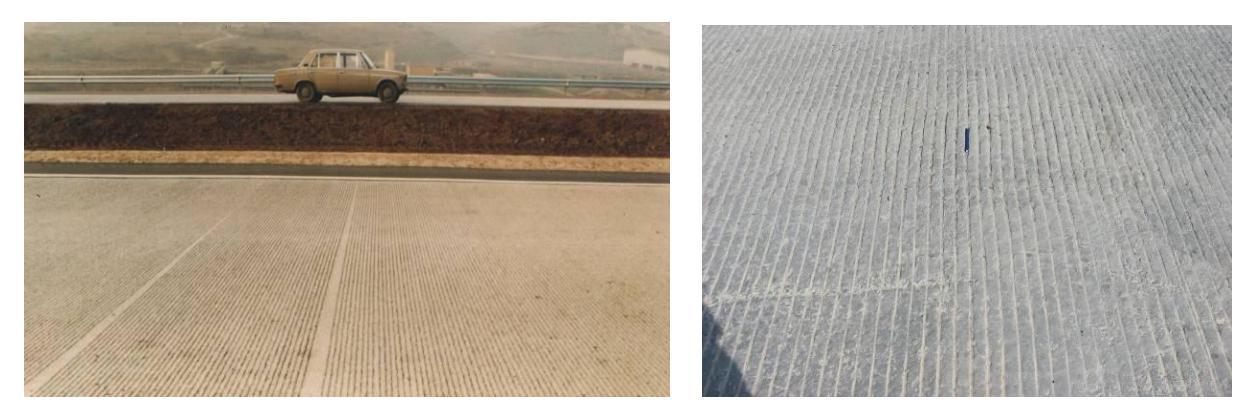
A texture 1.5 mm deep (measured in sand patch test) with streaks separated 25-30 mm was decided to be made after several test textures. Due to the use of good quality siliceous sand, the texture remains in quite good shape after 34 years without any treatment.

Photos 10 and 11 – State of the texture in 1975 and 2010

A long-lasting texture has been ensured thanks to the use of good quality siliceous sand in construction. While the texture decreased 17% the first year (1.59 ± 0.23 mm depth in sand patch test), later it has remained in very good condition, especially the macro-texture.

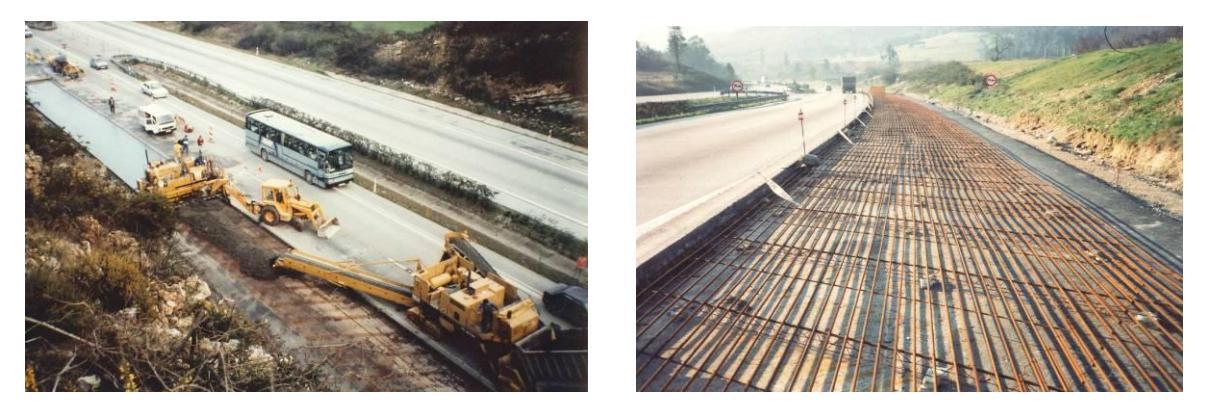
Photos 12 and 13 – The motorway was widened with an additional climbing lane in 1990

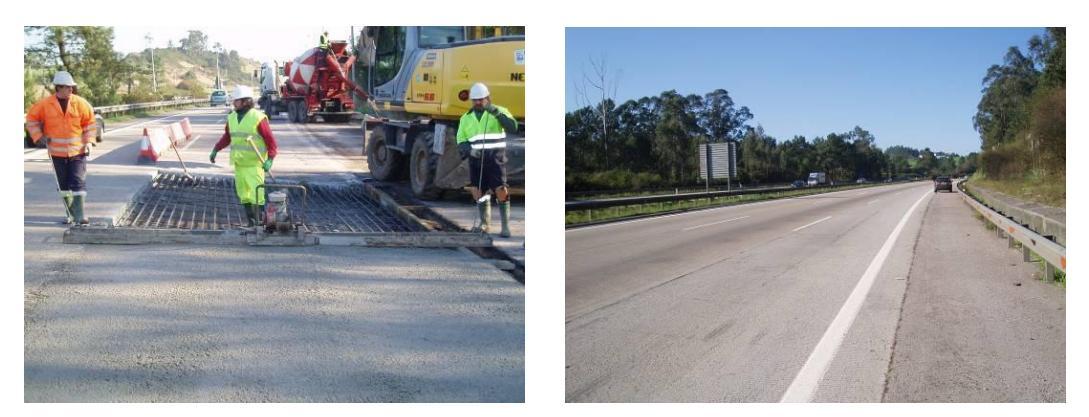
Three maintenance operations in the pavement have been made lately. Some distressed slabs and punch-outs have been repaired with fast-track concrete. Traffic is allowed after 3 or 24 hours once compressive strength exceeds 15 MPa depending on the type of concrete selected. All of them are small localized failures appeared in recent years.

Photos 14 and 15 – Maintenance operations in the pavement have been very scarce
